Water Compliance Inspection Report

***NPDES
Inspection Report***

***Eaglemill Farms
Lynden, WA***

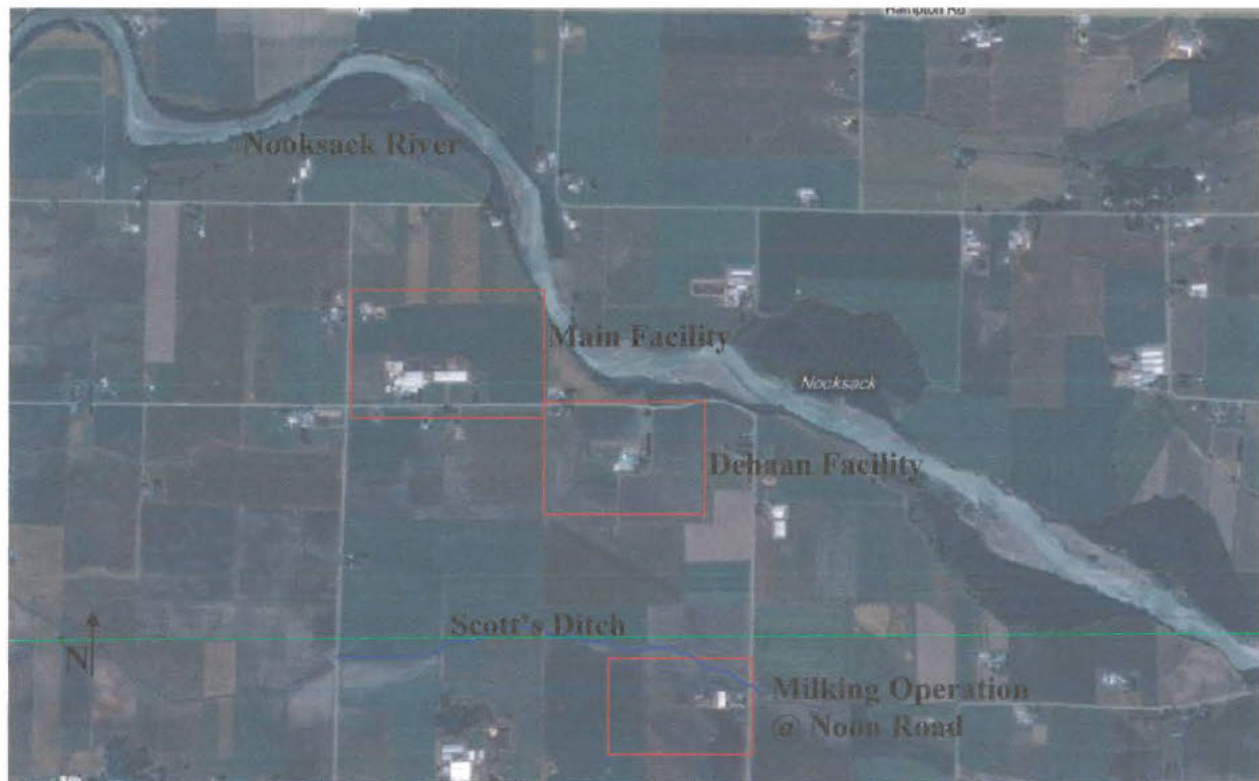
Eaglemill Farms is a large sized CAFO dairy operation that has been operated by (b) (6) since 1961. This facility does not have an NPDES permit. This operation consists of three separately located but interrelated facilities. All three are located in the same vicinity. The nearest waterway to the milking operation on Noon Road is Scott's Ditch, which is located north of the facility and south of the Dehaan Dairy. The Nooksack River is north of the main facility and the Dehaan Dairy. See Photo 1 for a satellite photo illustrating the proximity of these waters to the facilities.

Photo 1. Satellite Photo showing the location of all three facilities and their proximity to waters of the U.S.

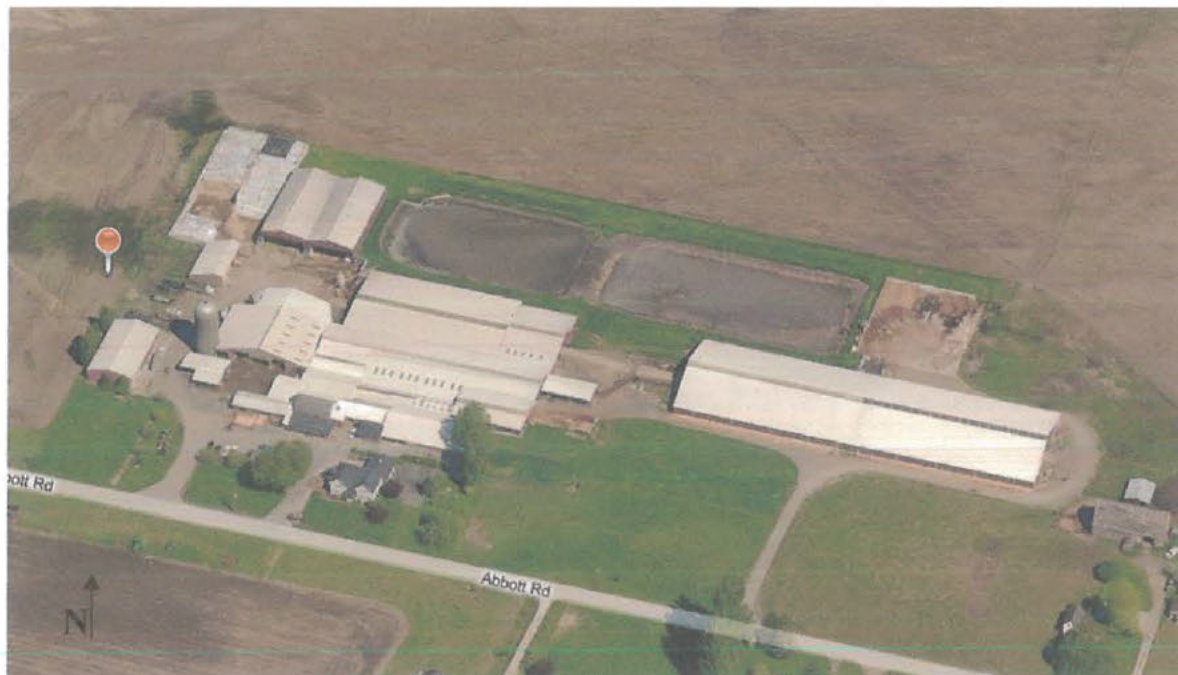
Photo 2. Aerial photo overview of the main facility for Eaglemill Farms Dairy.

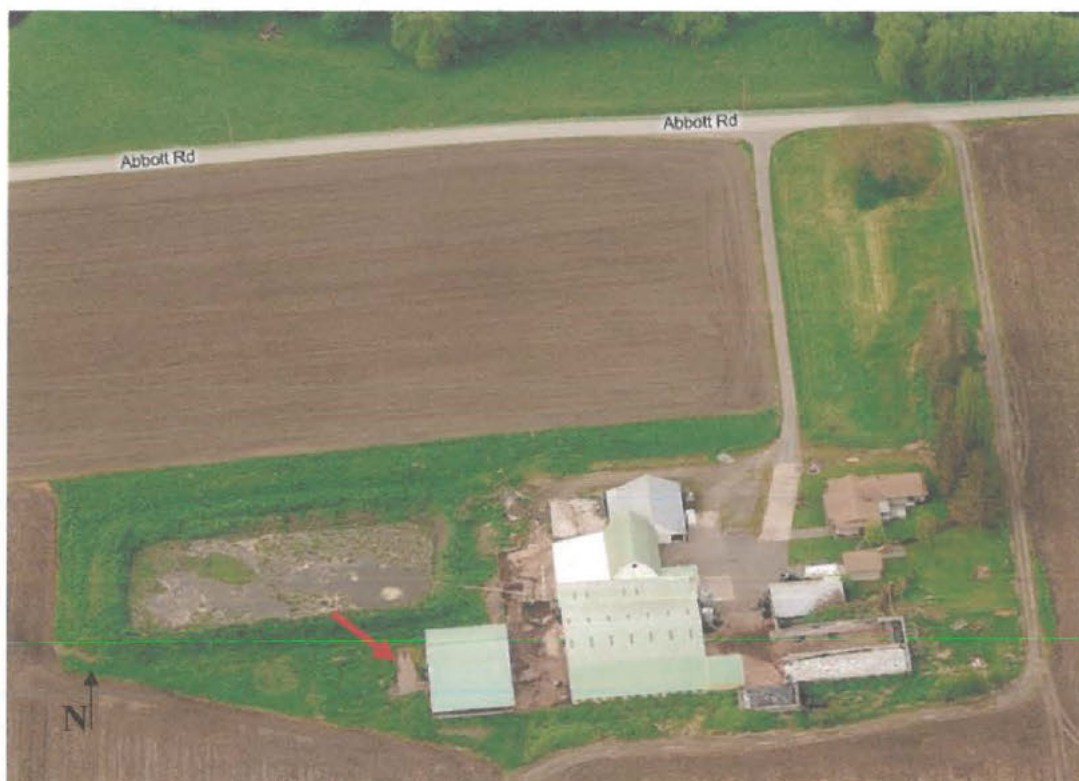
At the time of the inspection, there was manure waste starting to pile up just outside of two doorways on the west side of one of the confinement barns at the Dehaan Dairy (see Photos 3 and 4). During the inspection of the Dehaan Dairy facility, I told Mr. De Jong that the potential for waste to leave this building was an area of concern.

Photo 3. Aerial photo overview of the Dehaan Dairy Facility. The red arrow indicates the area where there is potential for waste to leave the barn (See Photo 4 on next page).

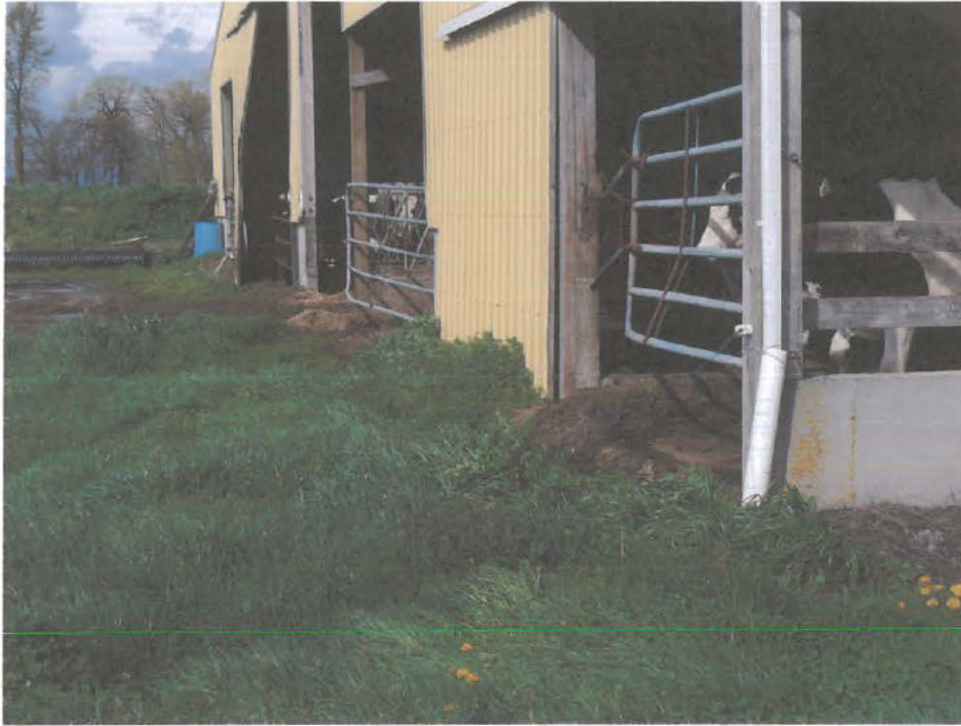
Photo 4. This is a close up photo of waste leaving the open doors of the barn at the Dehaan Facility.

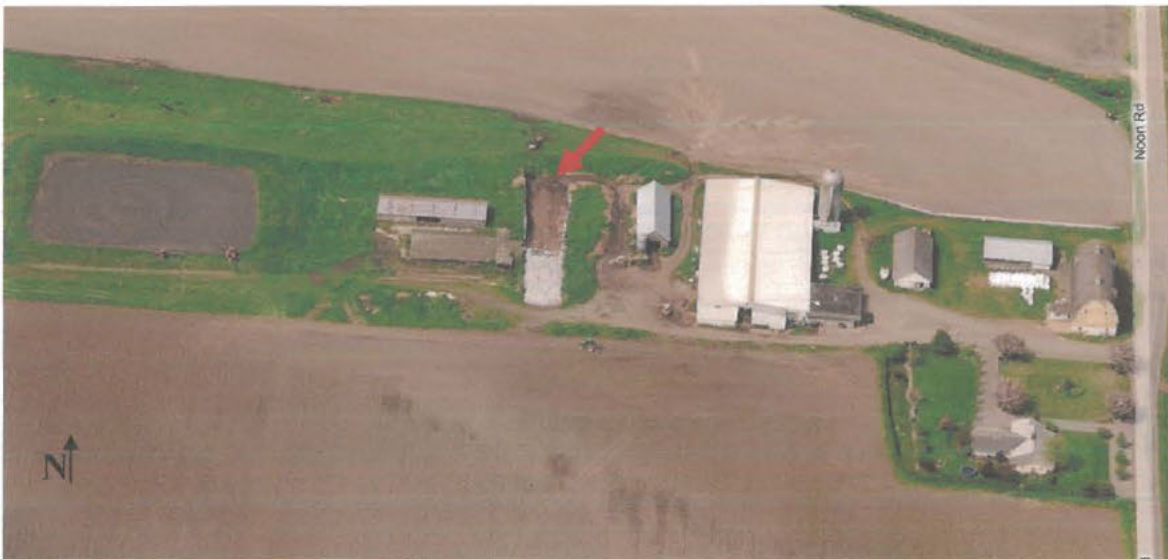
During the inspection of the Noon Road facility, we observed silage leachate water ponding at the ends of the feed storage area (See Photos 5 and 6). I told Mr. De Jong that the potential for this leachate water to flow to Scott's Ditch on the north side of this facility was an area of concern.

Photo 5. Aerial photo overview of the milking operation at 7585 Noon Road. The red arrow indicates the area where there is silage leachate ponding (See Photo 6 below). Scott's Ditch can be seen in the upper right corner of the photo.

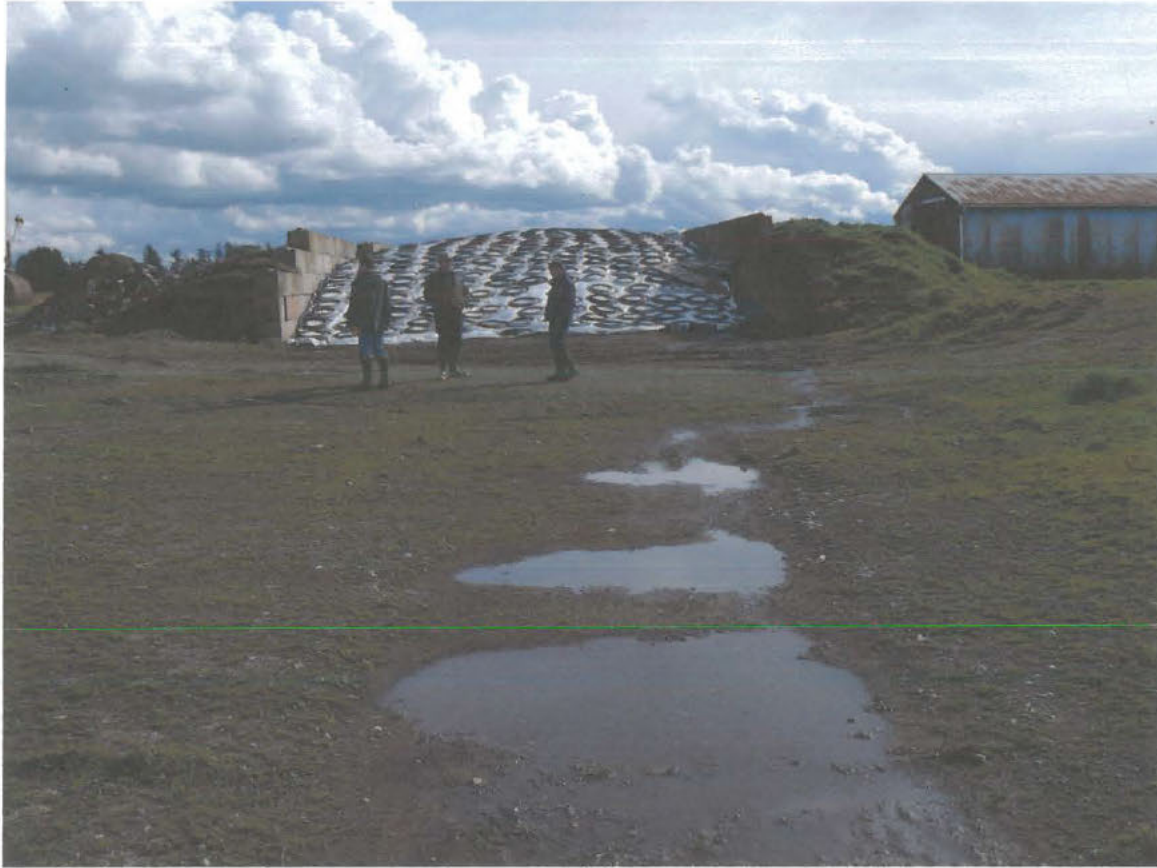
Photo 6. This illustrates the ponding of silage leachate on the north side of the feed storage area at the milking facility on Noon Road.
